DEPARTMENT OF TRANSPORTATION

Contract #: 04-0120F4Cty: SF/ALA Rte: 80 PM: 13.2/13.9File #: 69.28**WELDING INSPECTION REPORT****Resident Engineer:**Pursell, Gary**Address:** 333 Burma Road**City:** Oakland, CA 94607**Report No:** WIR-014095**Date Inspected:** 10-May-2010**Project Name:** SAS Superstructure**OSM Arrival Time:** 700**Prime Contractor:** American Bridge/Fluor Enterprises, a JV**OSM Departure Time:** 1900**Contractor:** Zhenhua Port Machinery Company, Ltd (ZPMC), Changxing Island **Location:** Shanghai, China**CWI Name:** An Qing Xiang, Yu Qi Guo**CWI Present:** Yes No**Inspected CWI report:** Yes No N/A**Rod Oven in Use:** Yes No N/A**Electrode to specification:** Yes No N/A**Weld Procedures Followed:** Yes No N/A**Qualified Welders:** Yes No N/A**Verified Joint Fit-up:** Yes No N/A**Approved Drawings:** Yes No N/A**Approved WPS:** Yes No N/A**Delayed / Cancelled:** Yes No N/A**Bridge No:** 34-0006**Component:** Tower**Summary of Items Observed:**

WELDING INSPECTION REPORT

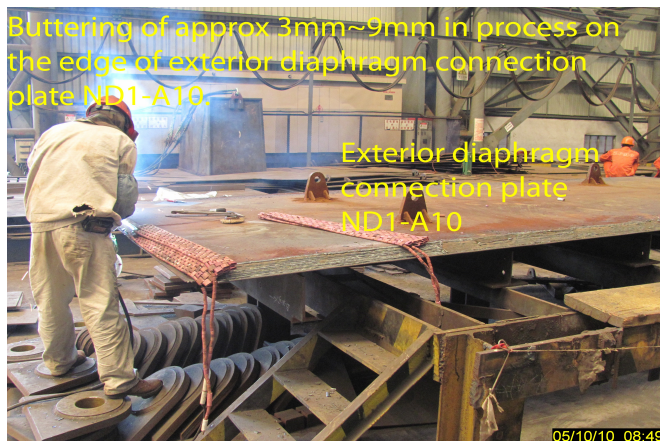
During random in process inspection, this QA inspector observed that ZPMC personnel was performing buttering of about 3mm~9mm on the edge of exterior diaphragm connection plate of ND1-A10. Welder is identified as 053869. ZPMC QC is identified as Mr. Yu Zhi Lai. The welding variables recorded by QC appeared to comply with WPS-345-FCAW-2G(2F)-REPAIR.
